# **Marine Coating Testing Five Years in a Tidal Stream**

**Final Report 2017**  
Coppercoat

**Reference:** PMA 139

**Date:** March 2018

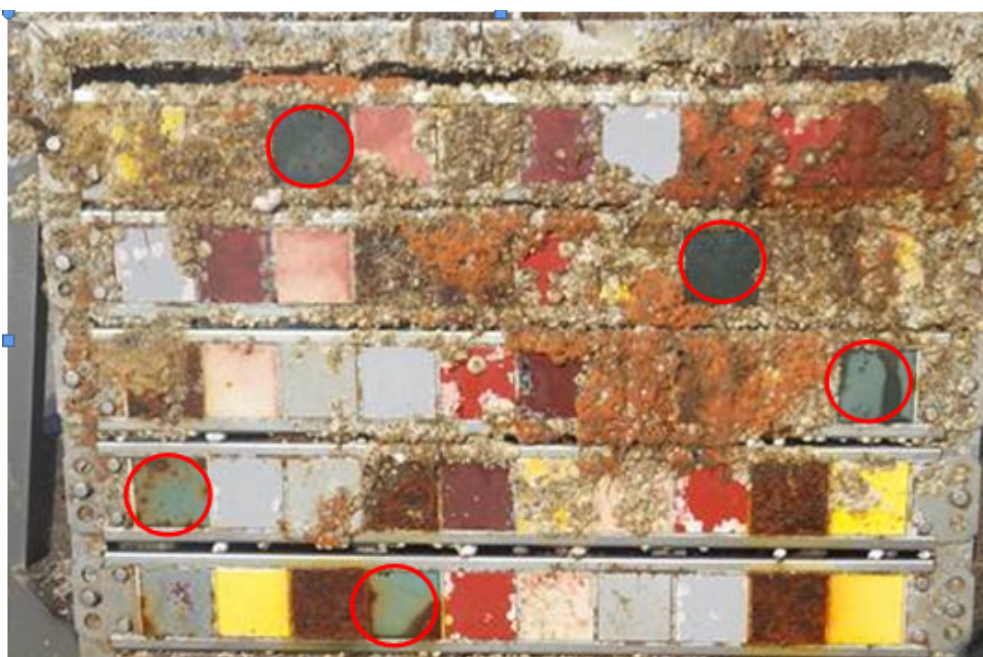
The abundance of fouling and coating damage was highly variable between coating types. Within each coating type, the position on the pod appeared to influence the amount of fouling present, with substantially less fouling on the lower two rows of the pod, presumably where scouring by mobile sediment had occurred.

**Figure 3:** Image of whole pod following recovery in 2017 after 60 months *in-situ*.

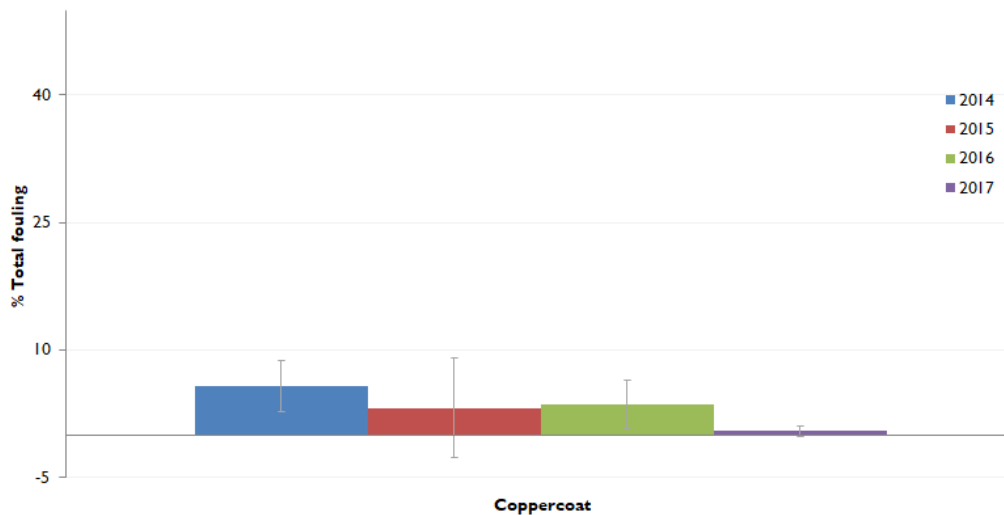
In most cases, the total abundance of fouling decreased over time from 2014, 2015 and 2017, and then usually increased during 2017. The exception in this trend were the “control” coatings – user applied – both of which failed extensively by 2015. By 2015, both of these panel types were essentially unprotected mild steel and covered in severe corrosion. To be noted that Coppercoat’s levels of fouling continued to decrease through 2017.

**Figure 5:** Total percentage cover of fouling from 2014 – 2017 based on ROV data or coarse level image analysis. Error bars indicate standard deviation. n= 10 in 2014, 10 in 2015, 9 in 2016 and 10 in 2017.

Coppercoat was among the top 3 systems with the lowest level of fouling which generally remained at below 10% coverage by fouling between 2014–2017.

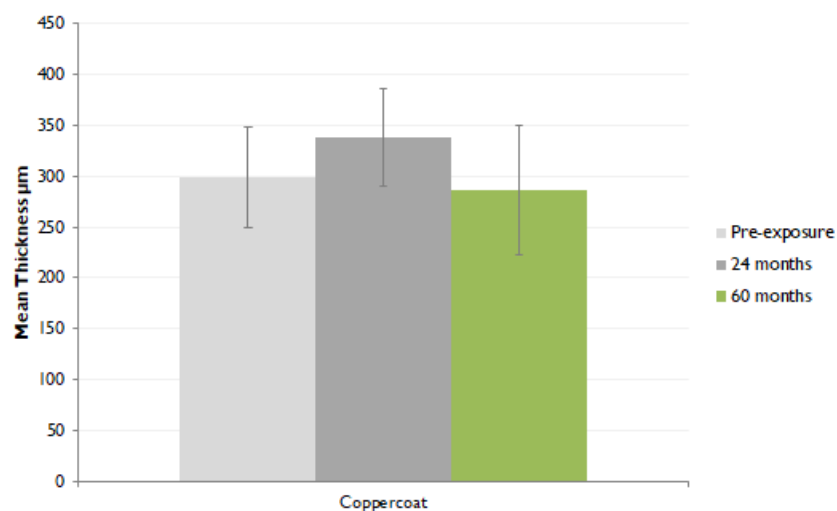
Coppercoat showed little significant change in thickness over time, excluding inter-panel variability.

Both user applied coating systems had disappeared almost entirely. The remained steel panels had corroded to such an extent that the blistering appeared to show an increase in thickness, but in reality very little if any coating matrix remained in place

**Figure 6:** Mean coating thickness pre-exposure, at 24 months and 60 months. Error bars show standard deviation, and n=3.
